Delaware Valley Works
Pore Water Sampling Event
Claymont, DE and Marcus Hook, PA
January 2019

**US Army Corps
Of Engineers**
Philadelphia District

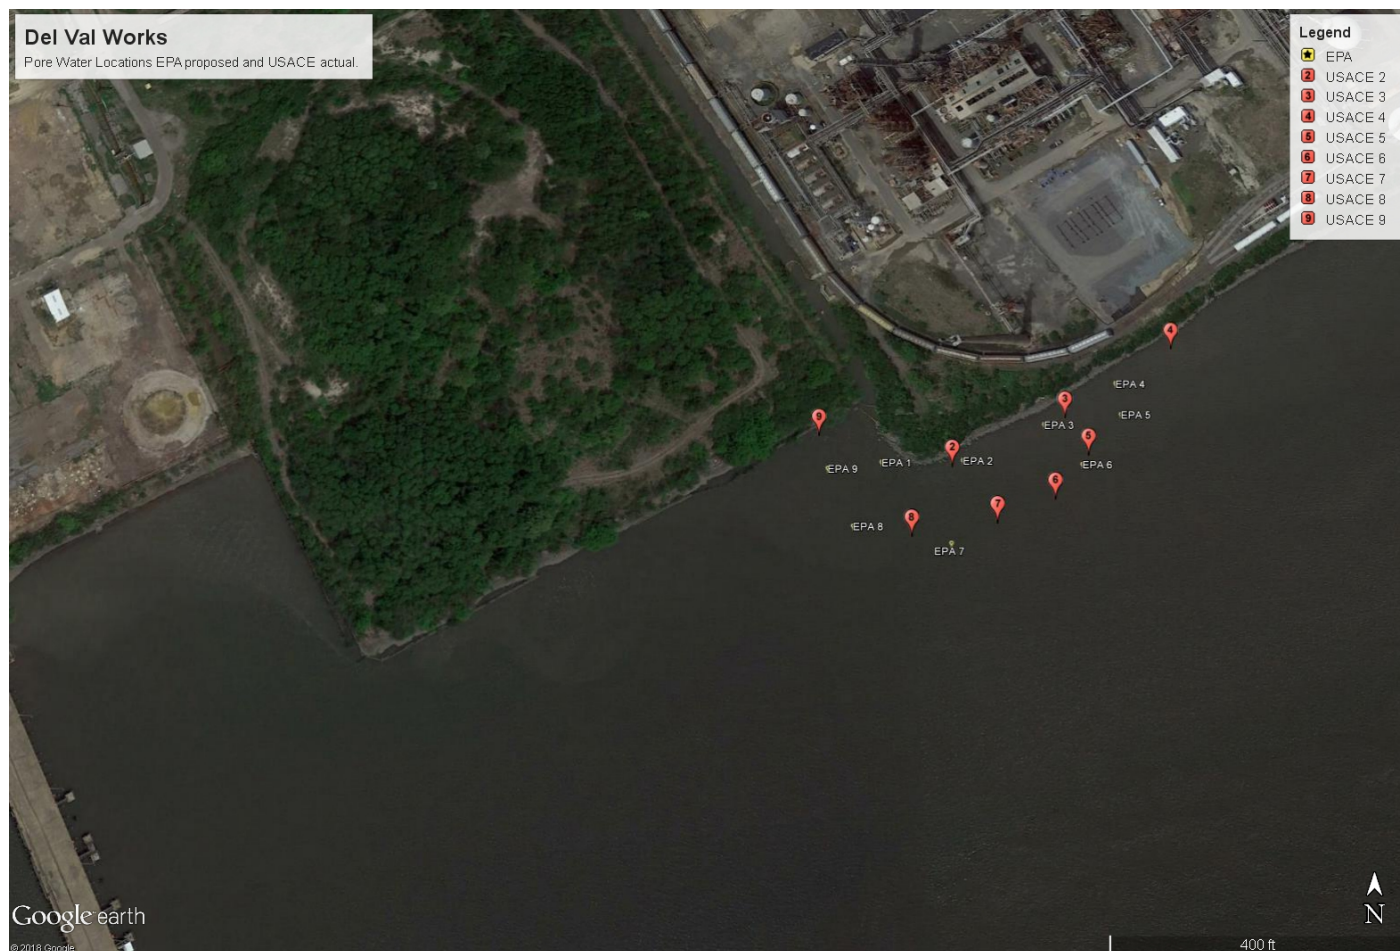
Figure 1 – EPA Requests and Actual Sample Locations

The Philadelphia District U.S. Army Corps of Engineers (NAP) sampling team for the first phase of the sampling effort consisted of two Geo-Environmental Section members and two NAP Operations Division Boat Operators. The team traveled by boat to the Delaware Valley Works (DVW) area in Claymont, DE and the adjacent Sunoco Refinery Facility in Marcus Hook, PA on October 1 and 2, 2018 to conduct the pore water sampling at the locations shown on Figure 1.

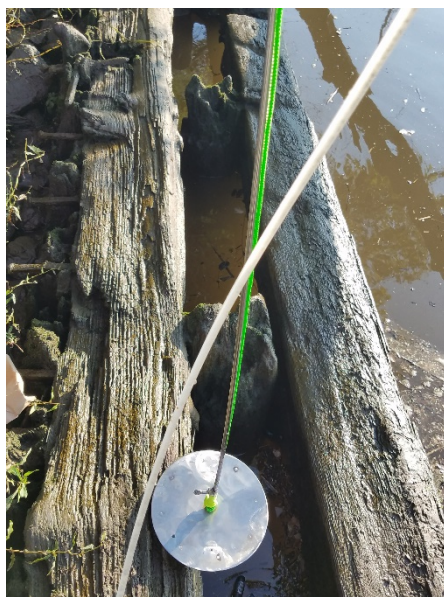
Assembled Pore Water Sampler showing plate, sampling tube, Teflon[®] tubing and retrieval line. Taken at Location 9.

For locations 5 through 8, the vessel was positioned as close as possible to the EPA coordinates using the on-board survey instrumentation. After positioning, the vessel was bow anchored and the sampling took place off the side on the aft deck. Six foot long pore water samplers were procured for this project due to the anticipated tidal range. The pore water sampler was attached to a stability plate at 15 centimeters from the bottom of the sampling probe. A retrieval line was attached to the plate and the top of the probe so they could be pulled aboard after the sampling. The probe was lowered to the bottom and relocated as necessary to permit the plate to rest firmly on the bottom. The interior

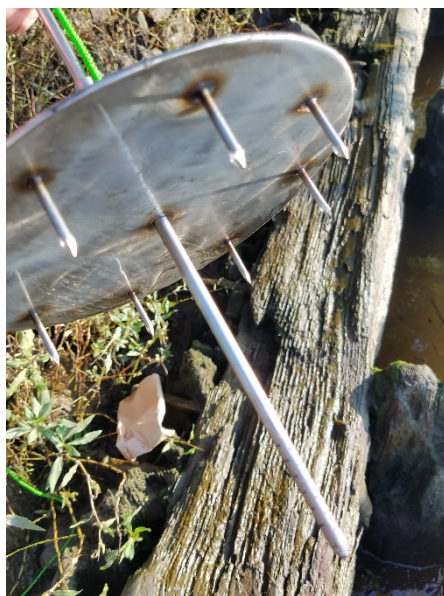
Bottom of plate showing spiked bottom and sampling tube.

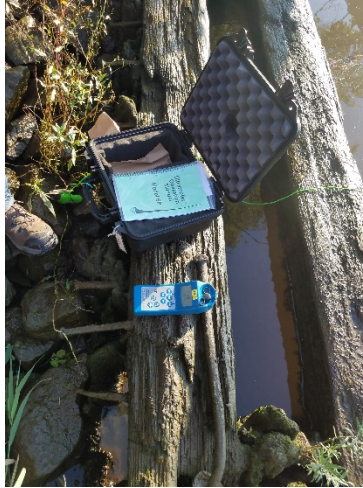
Myron Ultrameter Model 6P in use at sample Location 9.

- Improved stabilization procedures for the Myron meter to ensure that memory effects from previous samples do not lead to erroneous results.

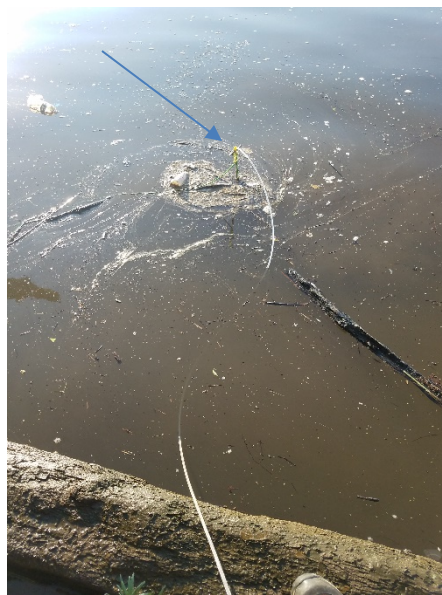
Sample probe deployed at sample Location 9. Note that the total probe length is 6 feet (~ 183 cm), with approximately 15 cm into the sediment.

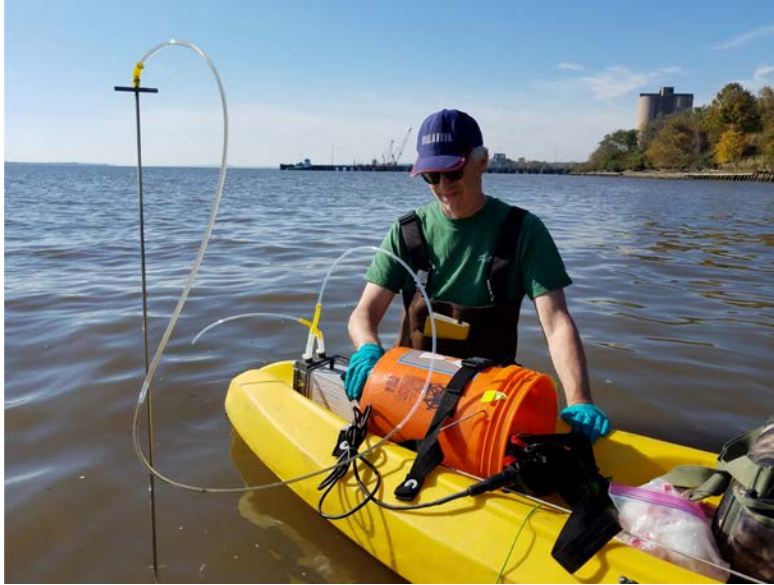
Typical kayak-based sampling. Peristaltic pump purging pore water from the sampling probe (left).

For sample locations 1 through 4, two sit on-top kayaks were brought to the DVW South Plant shoreline within SWMU 9 and were used to access these locations. The boats were loaded with the sampling equipment and the sampling team wearing chest waders and personal flotation devices paddled the boats to the sampling locations. The boats were beached on the rip rap shoreline, unloaded and one was then used as a sampling platform. One USACE sampler entered the water and walked out through the rip rap to find the presumed toe and a soft bottom sediment area. The actual position was determined by visual inspection of landmarks on the shore that were close to the original locations identified by the EPA. After identifying the appropriate location, the GPS-determined coordinates (presented in Table 1) were recorded, the sampling probe was inserted and sampling was conducted. One sampling modification incorporated into the phase two effort was the use of a peristaltic pump for withdrawal of the pore water rather than the

syringes, as the ability to maintain a stationary position in the river eliminated the difficulties encountered with boat drift/wave action in phase one. The peristaltic pump allowed for the withdrawal of more pore water and also enabled the sampling crew to field filter the dissolved arsenic samples using an in-line filter and preserve the dissolved arsenic samples in nitric acid preserved bottles. Filtration of the phase one dissolved arsenic samples was attempted with small cartridge filters affixed to the end of the syringe, but these filters clogged with solids almost immediately, resulting in the requirement to submit unpreserved water samples for lab filtration followed by analysis for dissolved arsenic. Another phase two modification was incorporated to address apparent memory effects with ORP readings on the Myron meter. Following all water testing, the Myron cell was filled with the pH 4 buffer which is recommended for long term storage of the meter. This change led to more consistency with the ORP readings observed for the river samples.

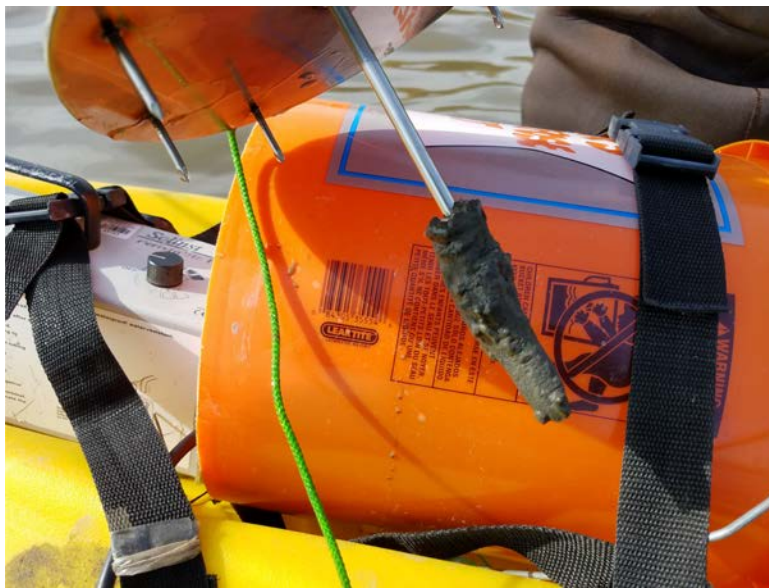
Location 1 showing the thick sediment. No pore water could be collected at this location.
